Manhole Inspection Summary

Manhole # S43UU_042MH

Location Address: **1661 ABBOTSTON ST**

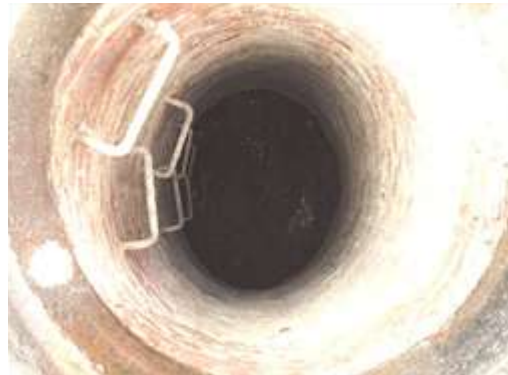
Top View

Channel debris.

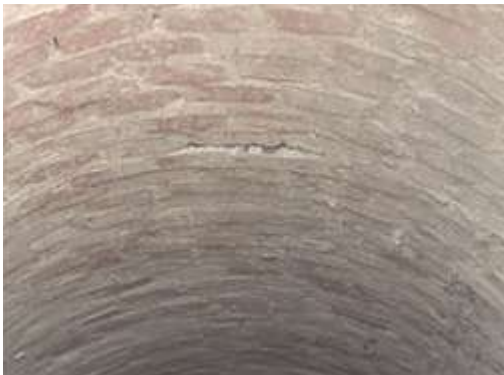
Defect

Condition: ☐ Sound ☐ Cracked ☐ Root Intrusion ☐ Loose Brick ☒ **Deteriorated**

Infiltration: ☐ None ☐ Joint ☐ Cracks ☐ Mortar ☐ Roots ☒ **Wall**

Corbel deterioration and infiltration.

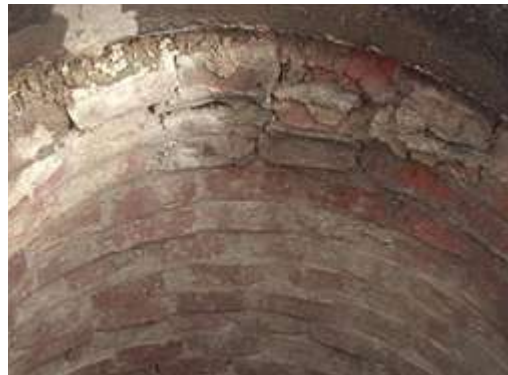
Defect

☒ **Leaks**

Condition: ☐ Sound ☐ Cracked ☐ Root Intrusion ☐ Loose Brick ☒ **Deteriorated**

Infiltration: ☐ None ☒ **Joint** ☐ Cracks ☐ Mortar ☐ Roots ☒ **Wall**

Frame leaks. Adjustment deterioration and infiltration.

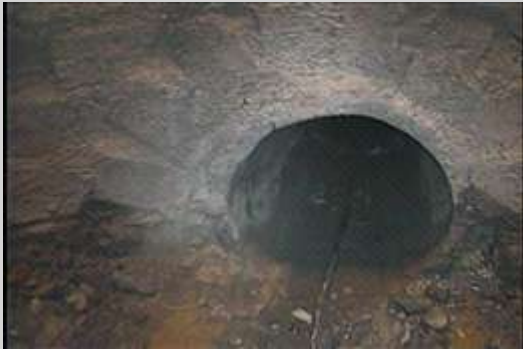
8 in. Circular Gravity Sewer
Pipe Out @ 12 O'Clock

Deposits: ☐ None ☒ **Mud** ☐ Sludge ☒ **Debris** ☐ Grease

Silt Depth: **0.5** (in.) Deposits Extent: **Light**
